# Manhole Inspection Summary

Manhole # S15EE2005MH

Insp Date: **7/13/06 11:36 AM**

**Location** Address: **1813 FAIRBANK RD**

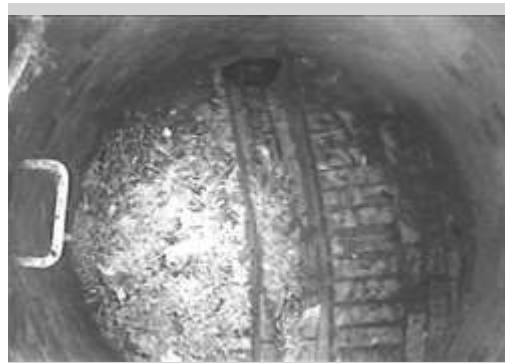
Top View

Infiltration: ☐ None ☒ **Joint** ☐ Cracks ☐ Mortar ☐ Roots ☐ Wall

Infiltration: ☐ None ☐ Joint ☐ Cracks ☐ Mortar ☐ Roots ☒ **Wall**

**Bench** ☒ Exists Material: **Brick** ☐ Parged ☒ **Debris** (not Condition related)

**Channel** Material: **Brick** ☐ Parged ☒ **Debris** (not Condition related)

Adjustment and Barrel infiltration. Bench and Channel debris.

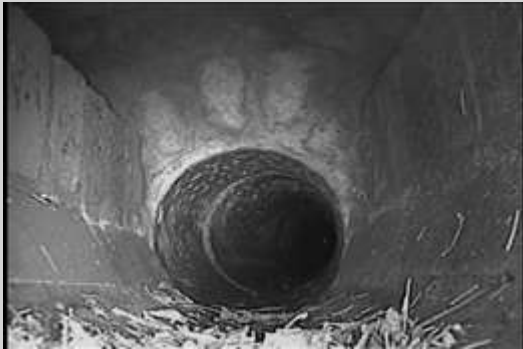
### 8 in. Circular Gravity Sewer Pipe Out @ 12 O'Clock

Pipe Material: **Clay** ☐ Pipe Lined

Invert Depth: **7.92** (ft.) Flow Characteristics: **Slow**

Deposits: ☒ None ☐ Mud ☐ Sludge ☐ Debris ☐ Grease

Infiltration: **None** Pipe Seal Cond: **Unknown**

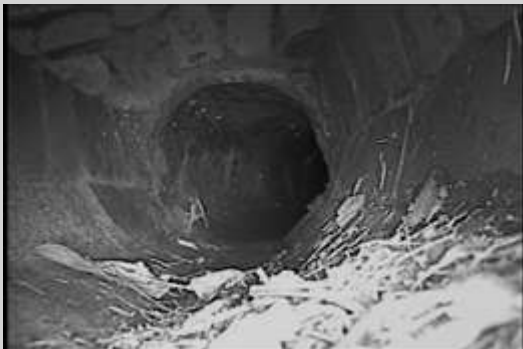
### 8 in. Circular Gravity Sewer Pipe In @ 6 O'Clock

Pipe Material: **Unknown** ☐ Pipe Lined

Invert Depth: **7.72** (ft.) Flow Characteristics: **Slow**

Deposits: ☒ None ☐ Mud ☐ Sludge ☐ Debris ☐ Grease

Infiltration: **Evidence** Pipe Seal Cond: **Unknown**
